## PRESSURE PULSATION IN A 175-LB STEAM LINE

ANATOMY OF A TANK FAILURE

## STABILITY OF ACID TANK SUPPORT STRUCTURE

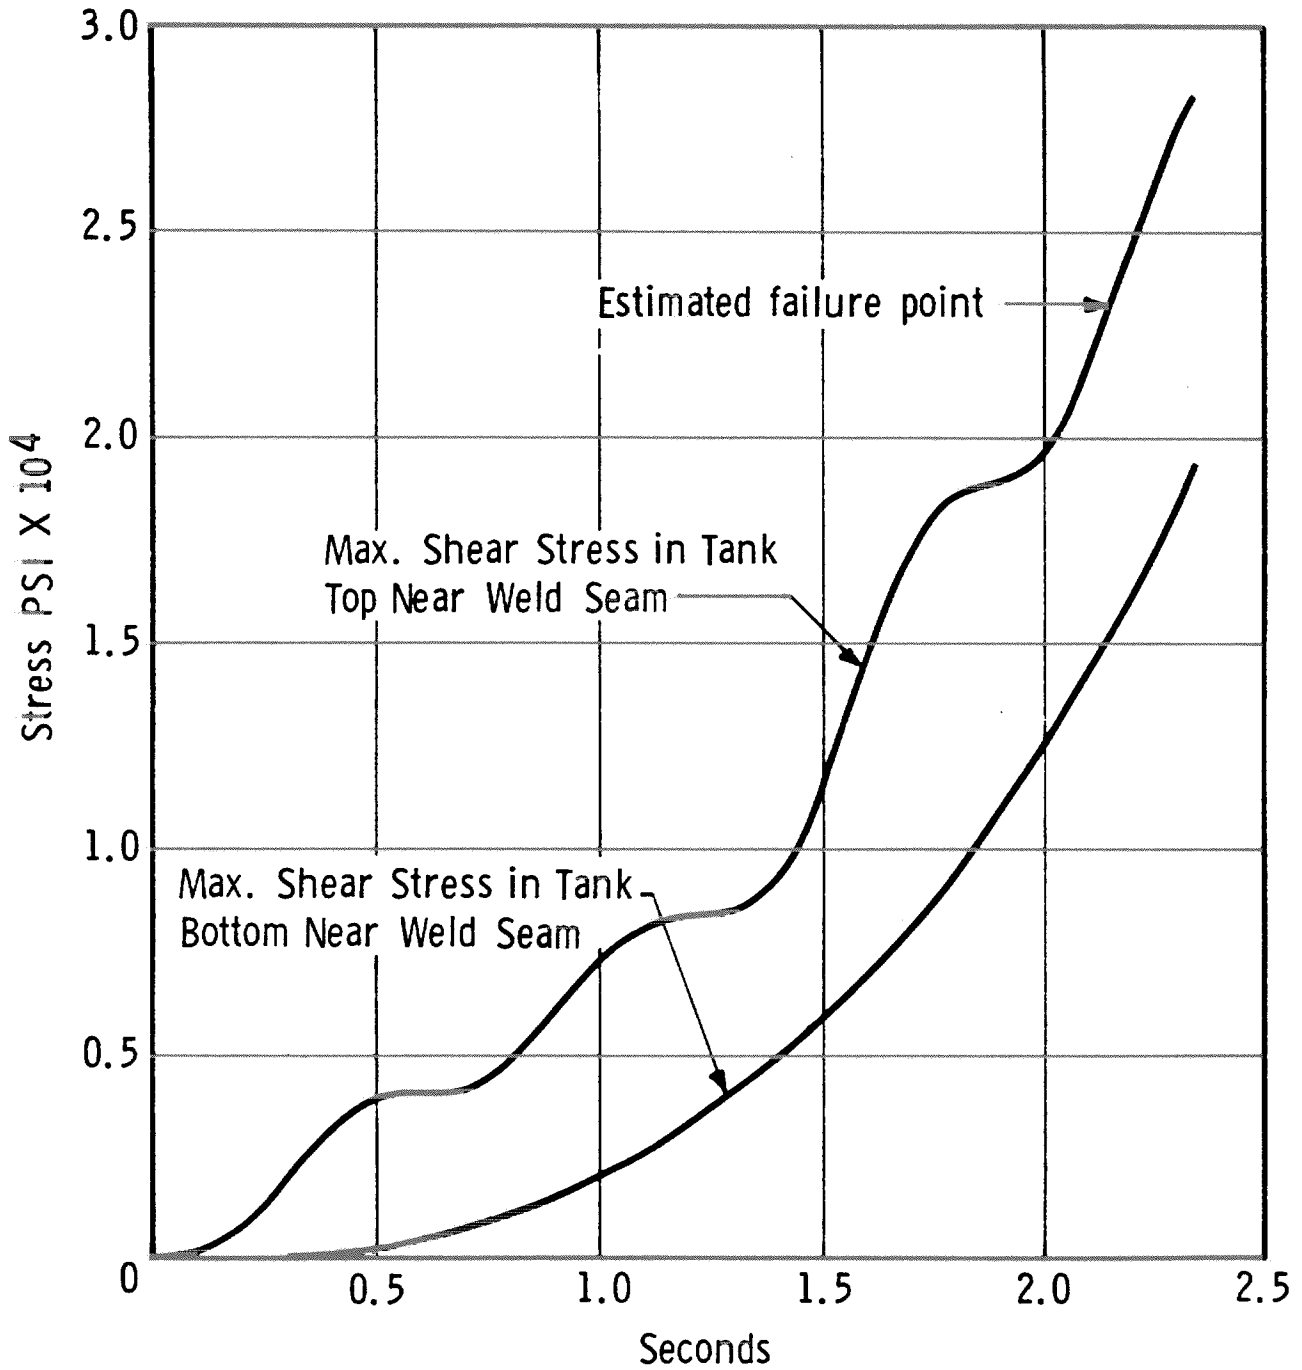
Figure 7

Two mathematical analyses were made of the tank: one a geometric nonlinear calculation to determine the stress distribution under static overpressure, the other a transient with a rapidly rising pressure approximating an explosion. The stresses corresponding to both cases were contour plotted separately and compared with the apparent stress distribution that caused the failure. Figures 7, 8, and 9 show stresses due to static and dynamic loading. The dynamic stress distribution showed maximum stresses occurring around the top edge of the tank, which matched the failure pattern. The maximum static stresses occurred around the bottom edge of the tank, far from the failure point. This provided evidence that the cause of the failure was a very rapid overpressure. Further analysis by explosion experts determined the possibility of hydrogen being present in the tank, and identified a potential ignition source. The system was redesigned to prevent this type of problem from recurring.

MAXIMUM SHEAR IN TOP AND BOTTOM SEAMS  
UNDER DYNAMIC LOAD
